Ellerton Estate - Stage 1, Melton South

Level 1 Inspection & Testing Report

Reference: 1120 0347-1

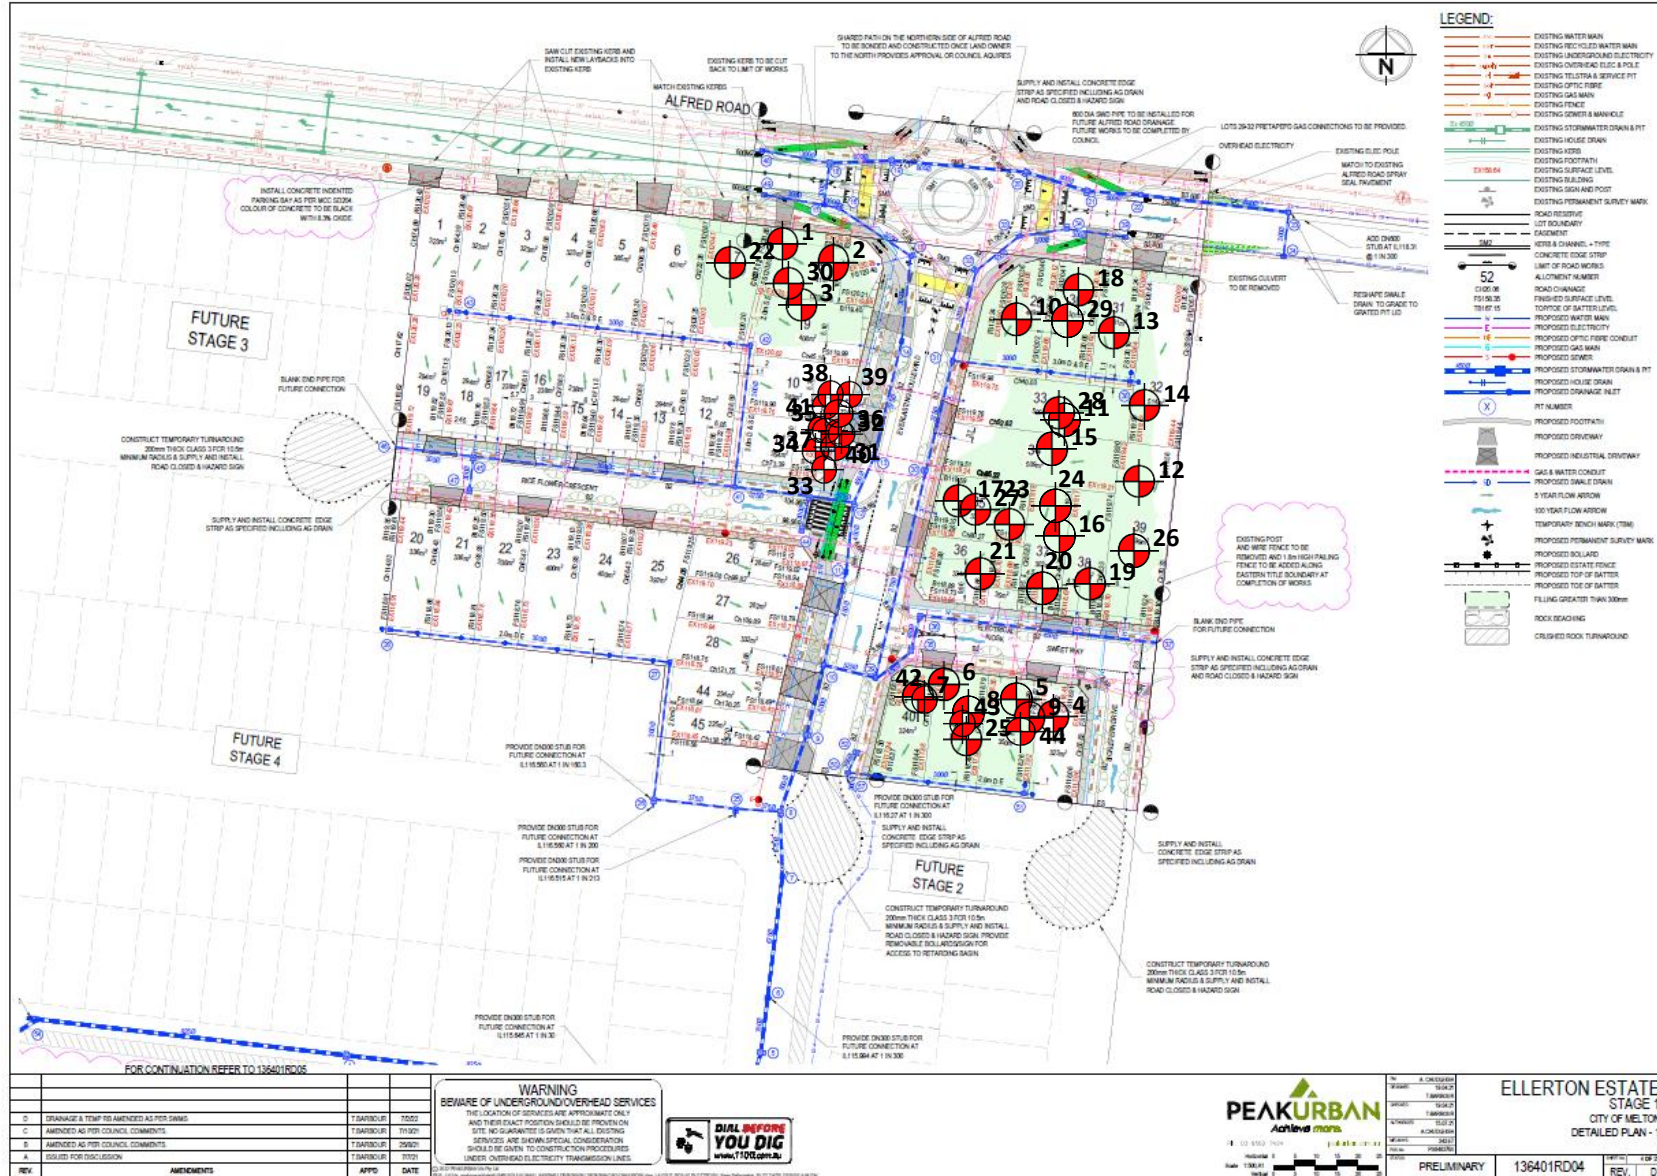
Indicative Test Location

Test Location	Refer to Plan	Refer to Plan	Refer to Plan			
Level/Layer	Layer 1	Layer 1	Layer 1			
Layer Thickness	mm 200	mm 200	mm 200			
Test Depth	mm 175	mm 175	mm 175			
Field Wet Density	t/m ³ 1.84	t/m ³ 1.85	t/m ³ 1.80			
Field Moisture Content	% 22.0	% 21.8	% 24.2			
Material:	Site Derived Clay Fill	Site Derived Clay Fill	Site Derived Clay Fill

Oversize Material	WET, %	0.0	0.0	0.0		
Sieve Size	mm	19	19	19		
Peak Converted Wet Density	t/m ³	1.87	1.87	1.83		
Optimum Moisture Content	%	23	22.5	22.5

Moisture Ratio	%	95.5	97	107.5		
Moisture Variation from OMC	%	-1.0 Drier	-0.5 Drier	1.5 Wetter		
Density Ratio	%	98.0	99.0	98.0

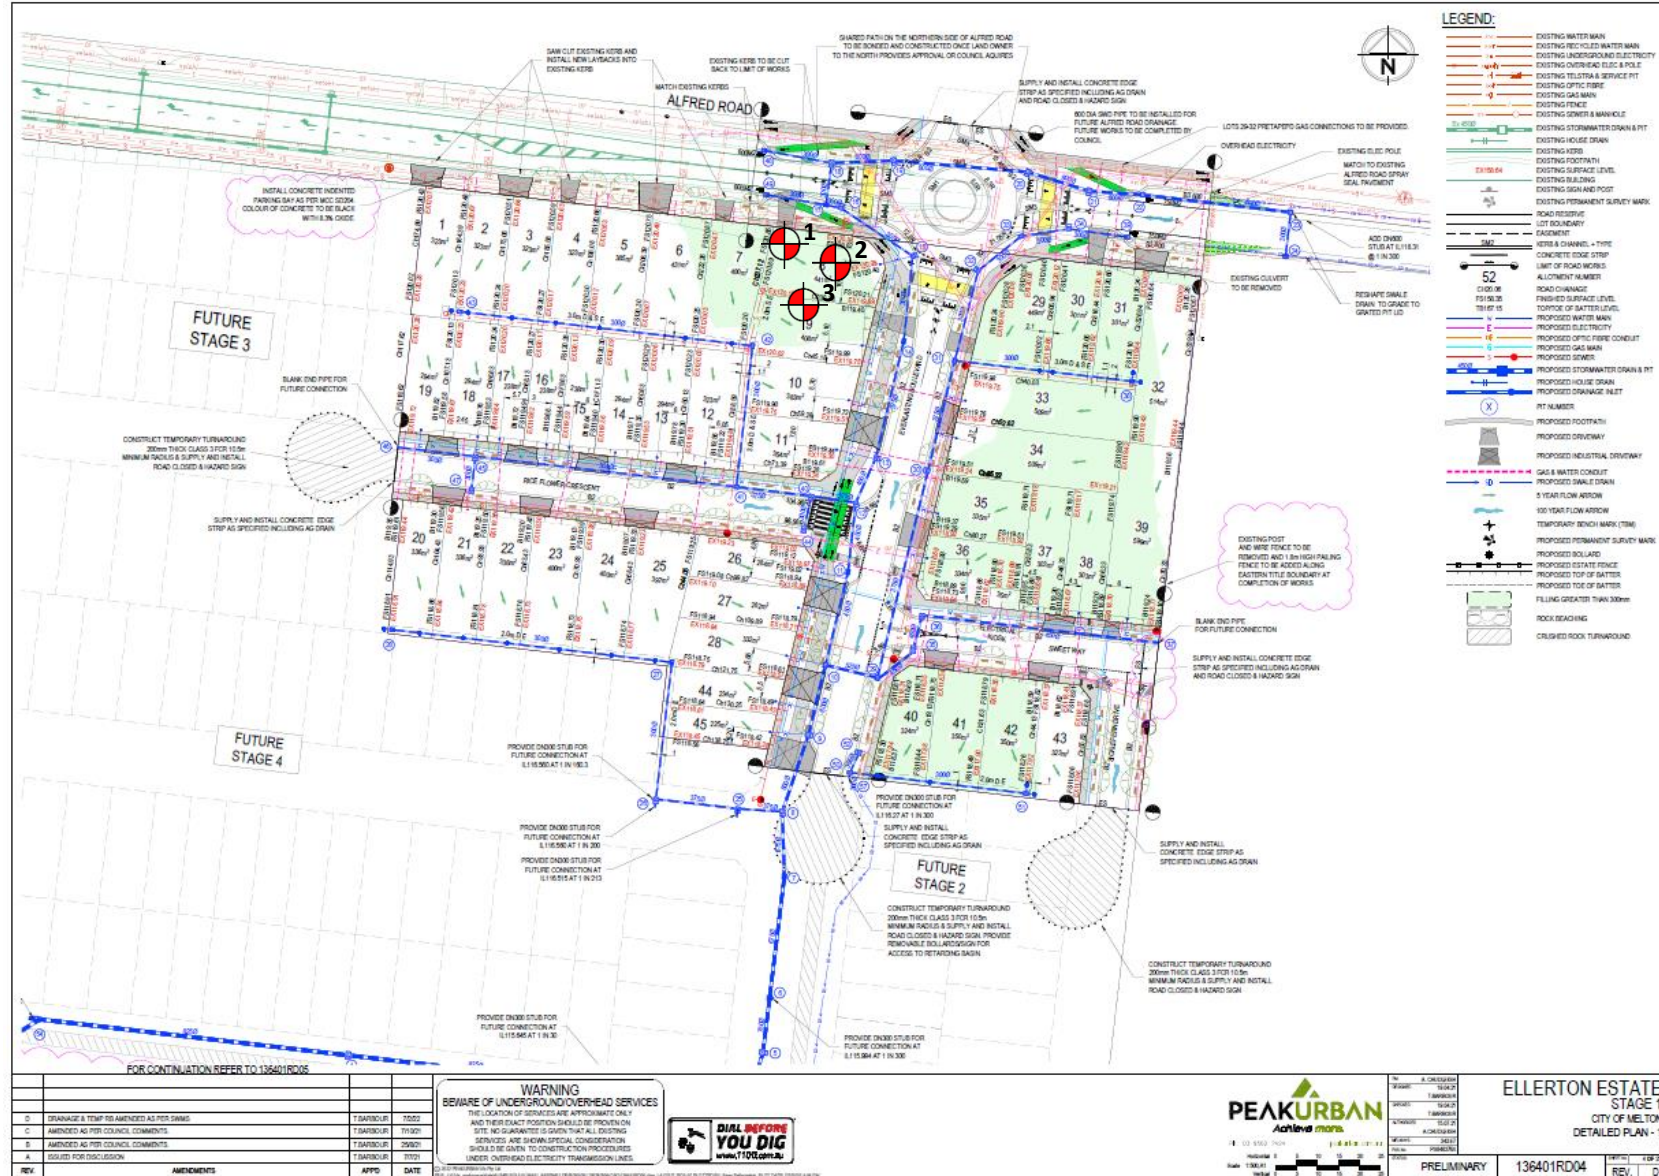
Test Location	Refer to Plan	Refer to Plan	Refer to Plan			
Level/Layer	Layer 1	Layer 1	Layer 1			
Layer Thickness	mm 200	mm 200	mm 200			
Test Depth	mm 175	mm 175	mm 175			
Field Wet Density	t/m ³ 1.88	t/m ³ 1.85	t/m ³ 1.81			
Field Moisture Content	% 25.6	% 26.8	% 26.0			
Material:	Site Derived Clay Fill	Site Derived Clay Fill	Site Derived Clay Fill

Oversize Material	WET, %	0.0	0.0	0.0		
Sieve Size	mm	19	19	19		
Peak Converted Wet Density	t/m ³	1.91	1.88	1.84		
Optimum Moisture Content	%	26.5	27.5	26.5

Moisture Ratio	%	96.5	97.5	98		
Moisture Variation from OMC	%	-0.5	-0.5	-0.5		
Density Ratio	%	98.5	98.0	98.5

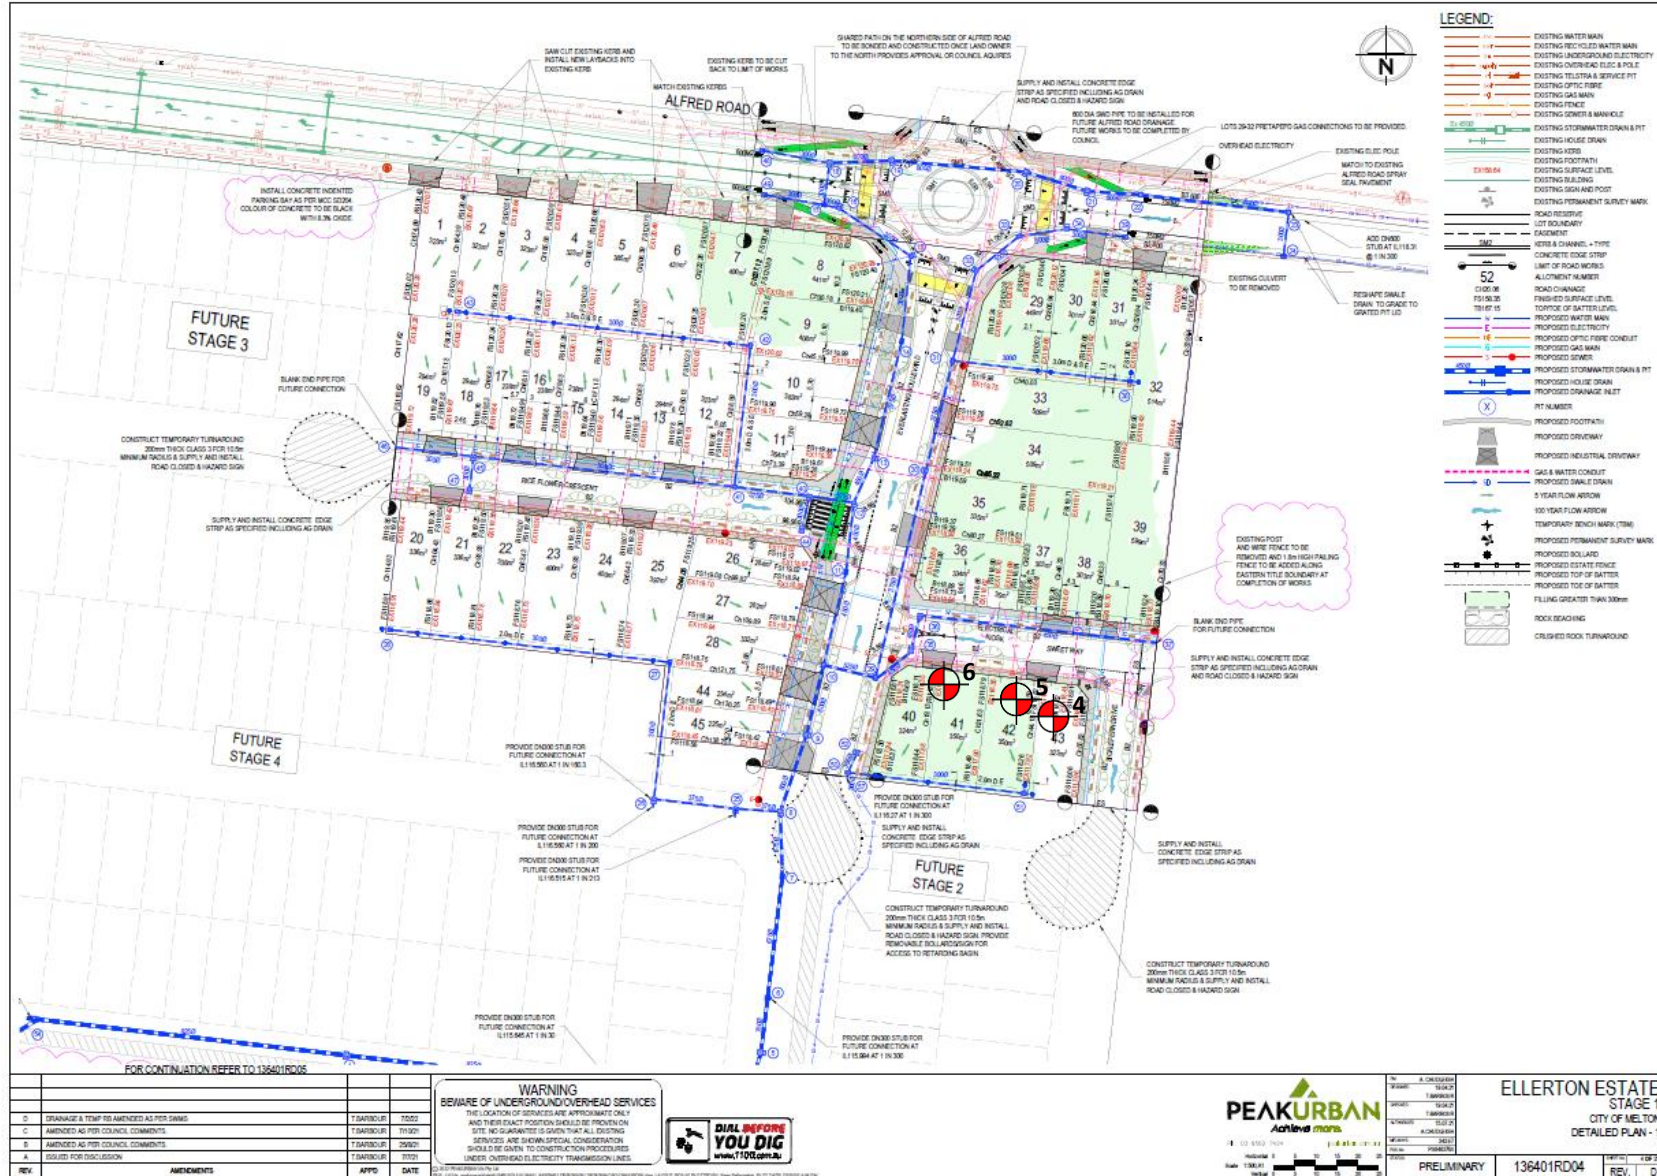
Test Location	Refer to Plan	Refer to Plan	Refer to Plan			
Level/Layer	Layer 2	Layer 2	Layer 2			
Layer Thickness	mm 200	mm 200	mm 200			
Test Depth	mm 175	mm 175	mm 175			
Field Wet Density	t/m ³ 1.65	t/m ³ 1.64	t/m ³ 1.65			
Field Moisture Content	% 27.1	% 26.8	% 27.4			
Material:	Site Derived Clay Fill	Site Derived Clay Fill	Site Derived Clay Fill

Oversize Material	WET, %	0.0	0.0	0.0		
Sieve Size	mm	19	19	19		
Peak Converted Wet Density	t/m ³	1.73	1.72	1.71		
Optimum Moisture Content	%	28	27.5	28.5

Moisture Ratio	%	97	97.5	96		
Moisture Variation from OMC	%	-1.0	-1.0	-1.0		
Density Ratio	%	95.5	96.0	96.0
